CITY OF BALTIMORE SMOKE TESTING OBSERVATION SUMMARY LOW LEVEL SEWERSHED

BALTIMORE CITY PROJECT 1029 REI/DRAYCO

Unique Test ID: 595 Date: 09/03/2008 Basin: LL - 44 Manhole ID: S19I__044MH Defect No: OB01 Supervisor: E.R. Crew: 04 Dye Test Recommended: N

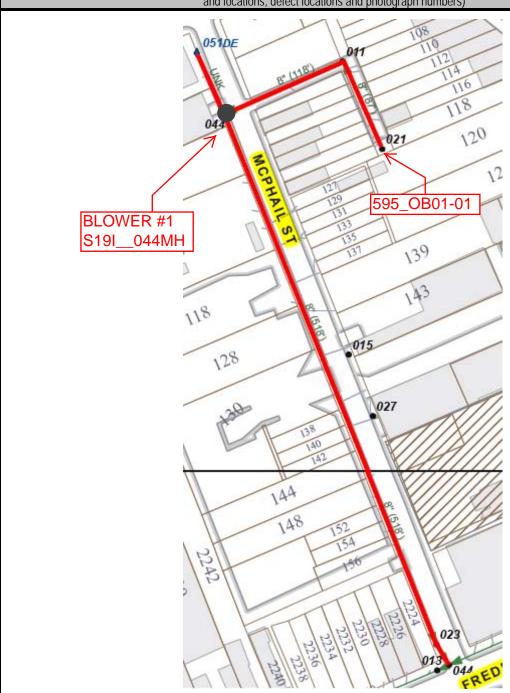
Field Sketch: (Show all manholes with numbers, blower placement location, sandbag or isolation locations, street names, building addresses and locations, defect locations and photograph numbers)

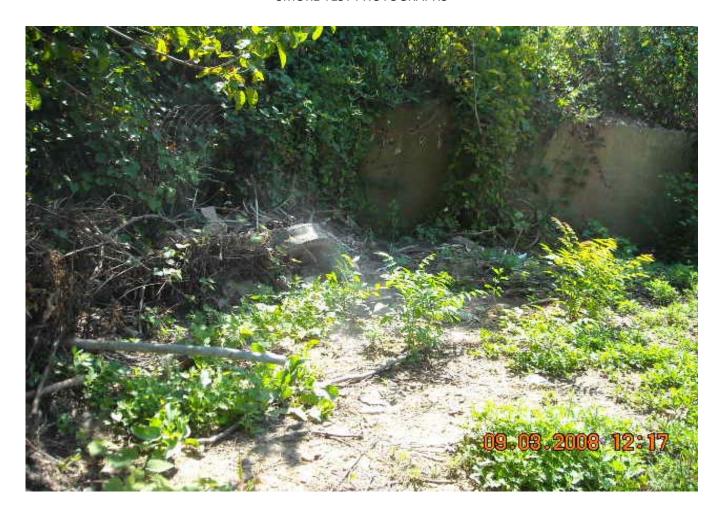
Photograph No: OB01-01 Filename: 1029-595_OB01-01.jpg

Location: S19I__021MH

Source Type: 10 Other Sector: 01 Public

Location: 14 Other Severity: 03 Moderate Drainage Area: 25 Comments: CANNOT LOCATE MANHOLE \$191_021MH BUT HEAVY \$MOKE IS COMING FROM THE

APPROXIMATE AREA.
